KARNS CITY AREA School District

PHYSICAL NEEDS ASSESSMENT

FEBRUARY 2017

ASSESSMENT: Chicora Elementary School

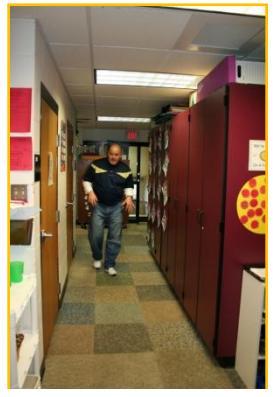
LACK OF SEPARATION BETWEEN KINDERGARTEN CLASSROOMS

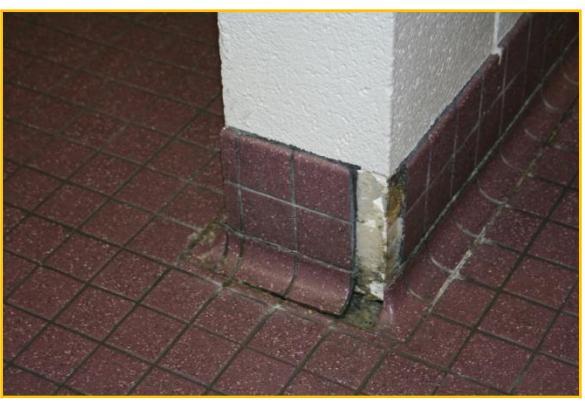
TOILET ROOM FLOOR TILE

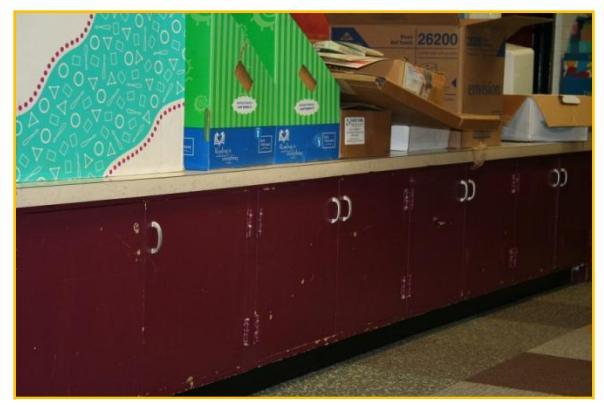
RE-FINISHED CASEWORK

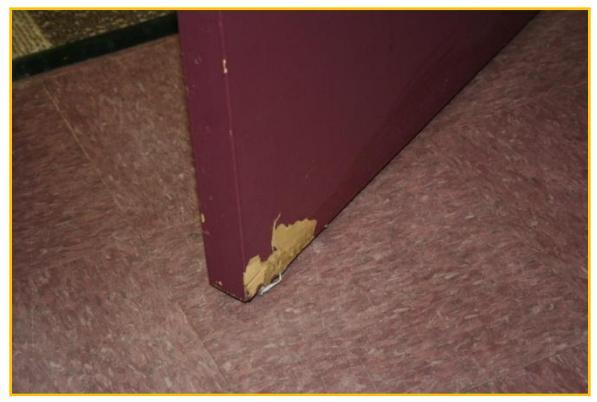
PAINTED CLASSROOM DOOR

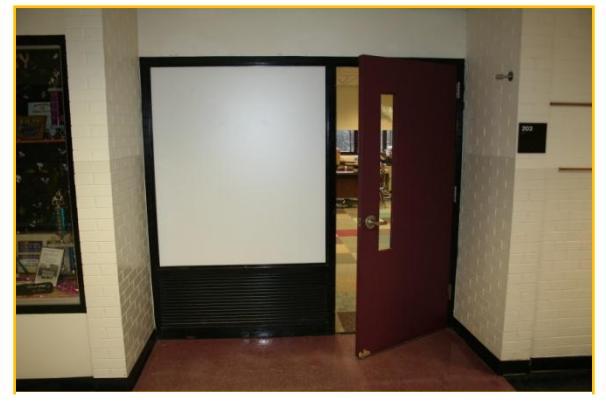
CLASSROOM ENTRANCE WITH OPAQUE PLEXI-GLASS

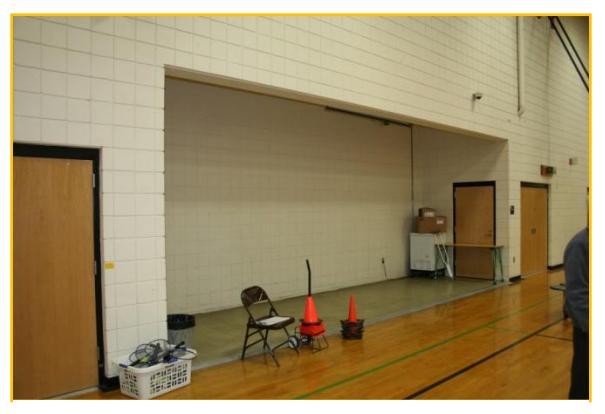
MULTIPURPOSE ROOM STORAGE ALCOVE

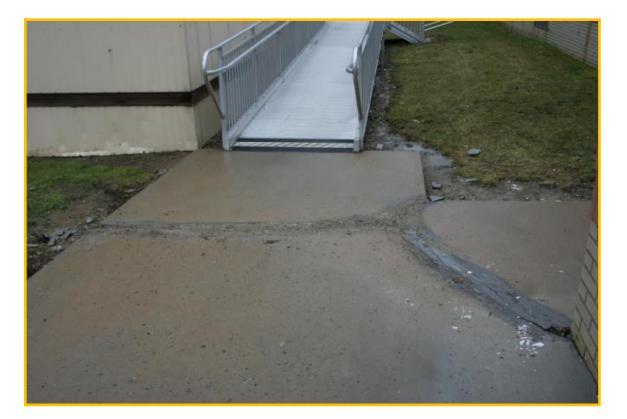
EXTERIOR CONCRETE AT MODULAR CLASSROOM

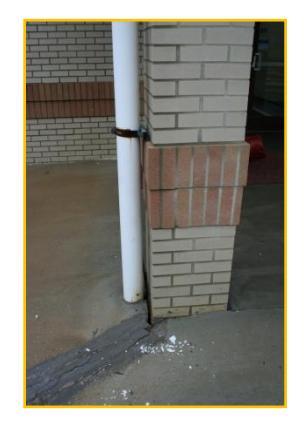
EXTERIOR CONCRETE AT MODULAR CLASSROOM

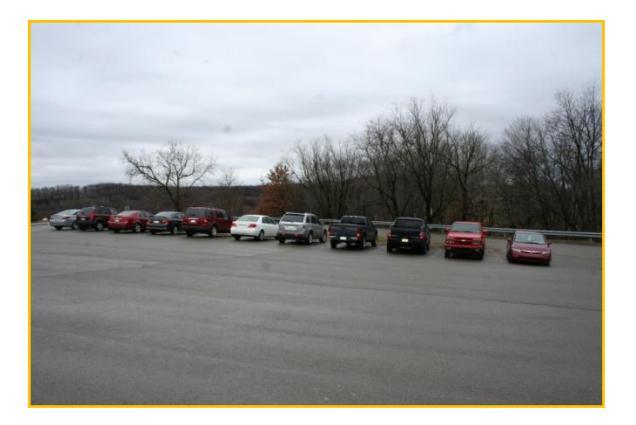
LACK OF HANDICAPPED ACCESSIBLE PARKING

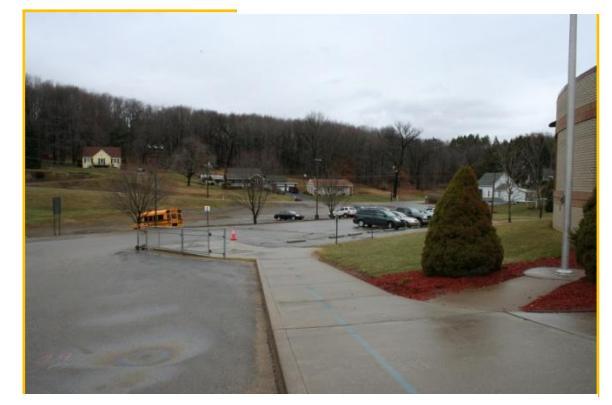
LACK OF HANDICAPPED ACCESSIBLE PARKING

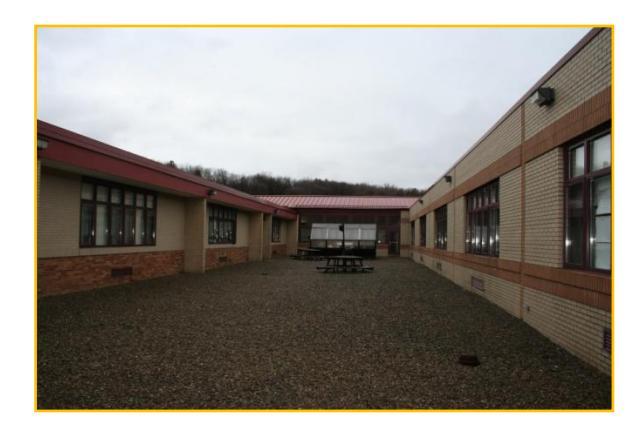
UNDER UTILIZED COURTYARD

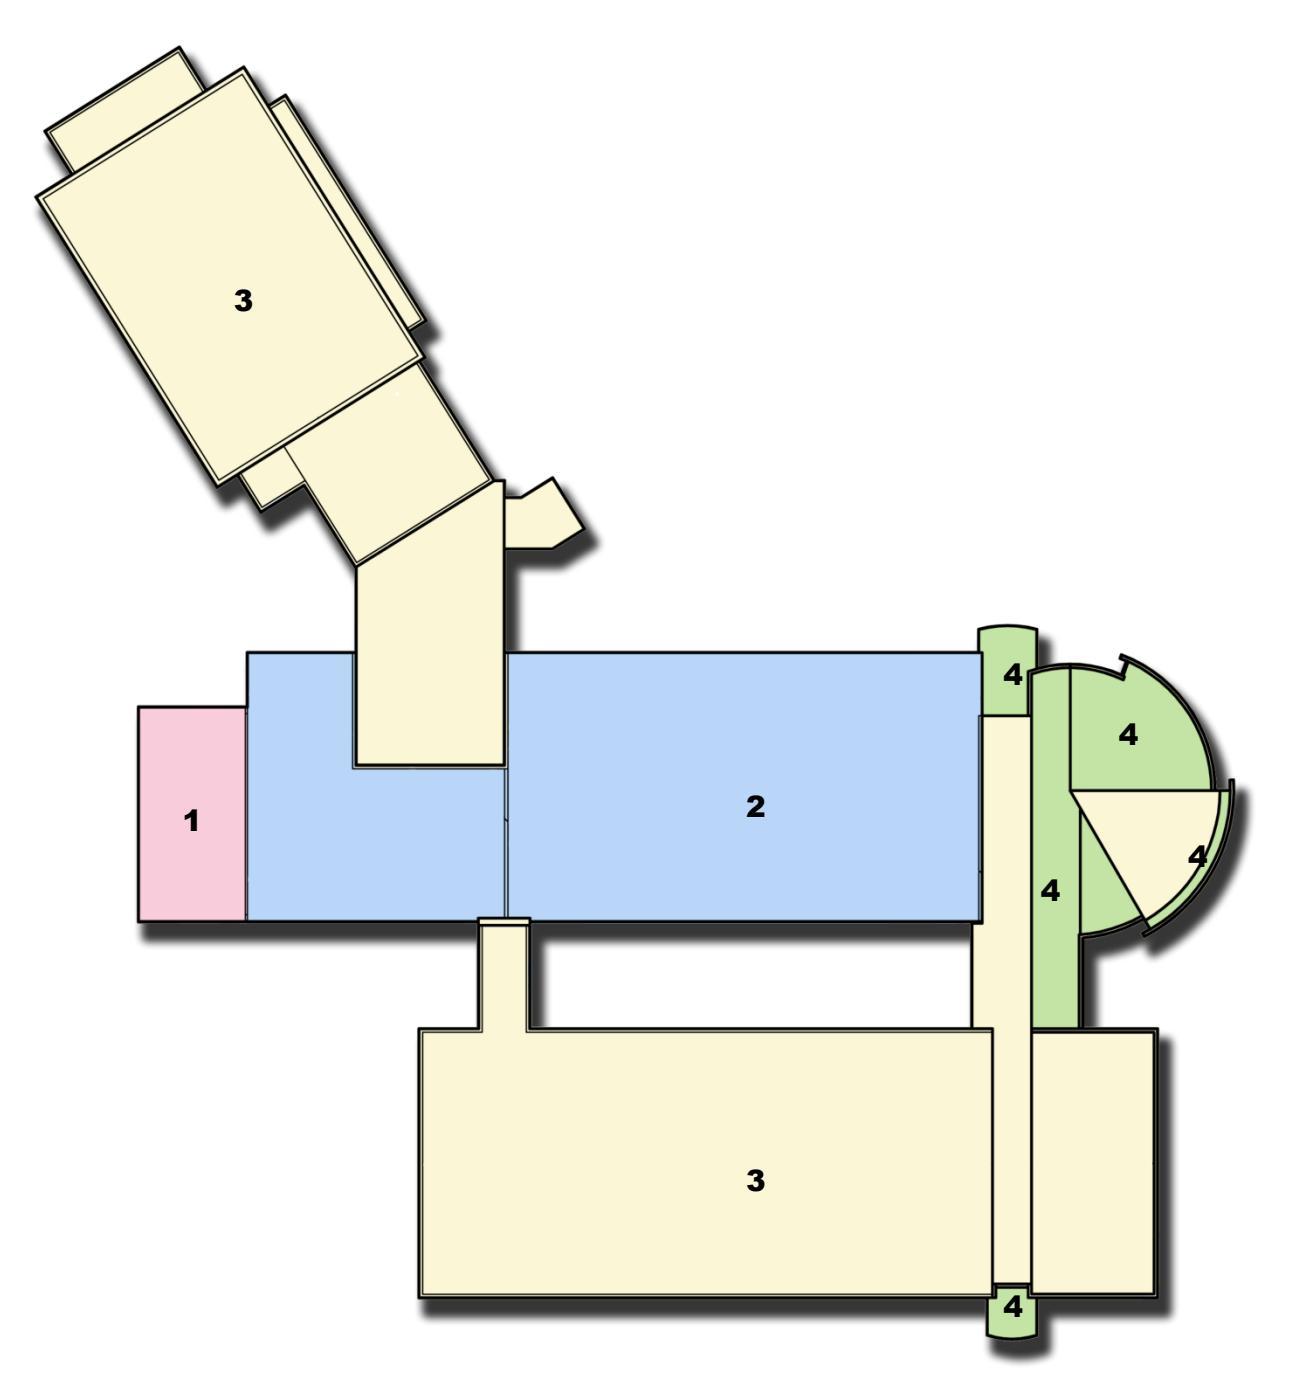
ROOF PLAN: Chicora Elementary School

- 1 Existing Garland Roof Warranty Expired 2007
- 2 Existing Garland Roof Warranty Expired 2014
- 3 Existing Siplast Mineral Surface Roof, Expired
- 4 Existing Garland Roof Warranty Expires 2037

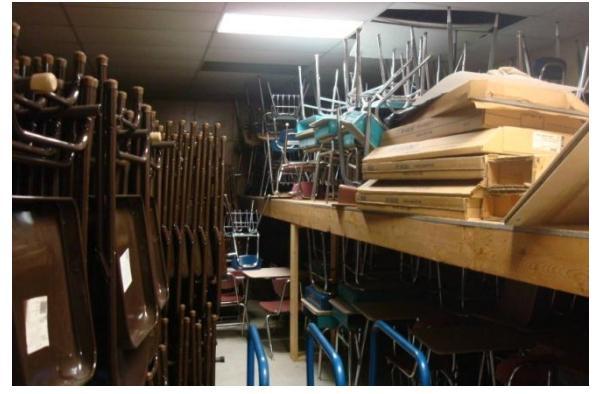
OVERCROWDED STORAGE ROOM

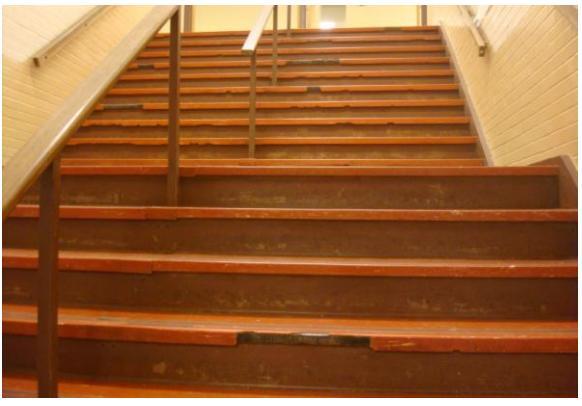
STAIRS WITH CRACKED TREADS

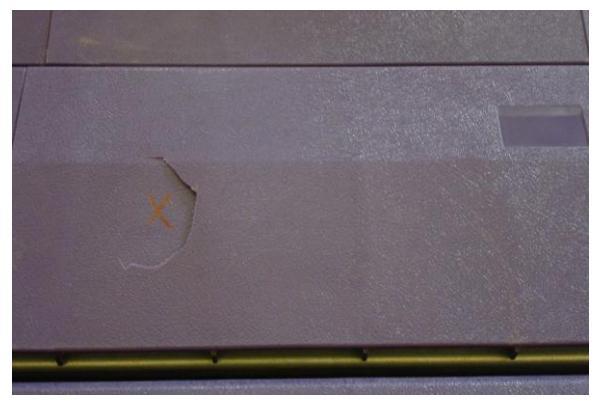
CRACKED BLEACHER FACE

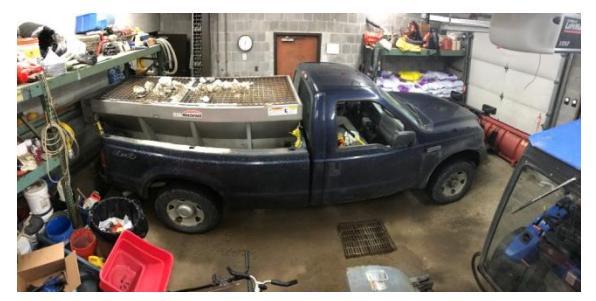
CROWDED MAINTENANCE GARAGE

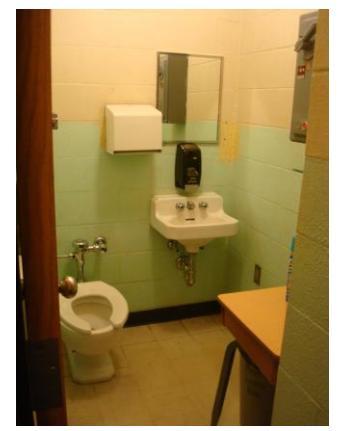
NON ACCESSIBLE TOILET ROOM

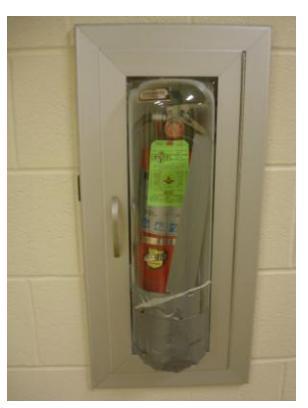
BROKEN FIRE EXTINGUISHER COVER

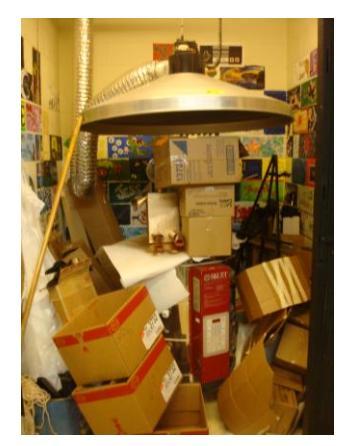
ART KILN UTILIZED AS STORAGE ROOM

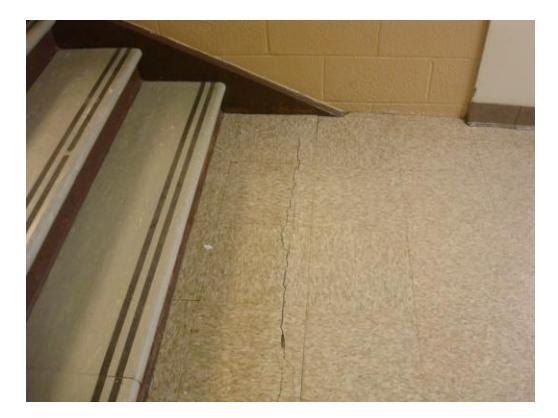
CRACKED FLOOR TILE

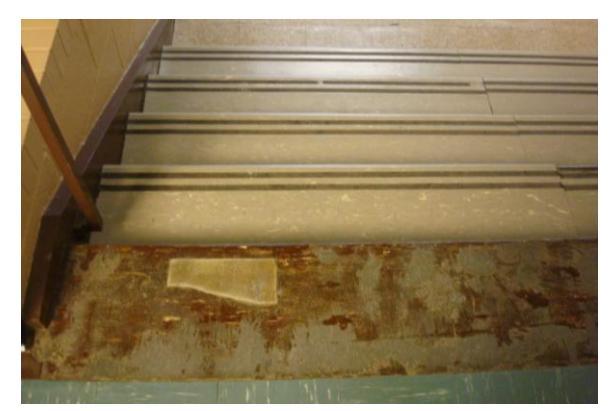
MISSING TILE AT STAIRS

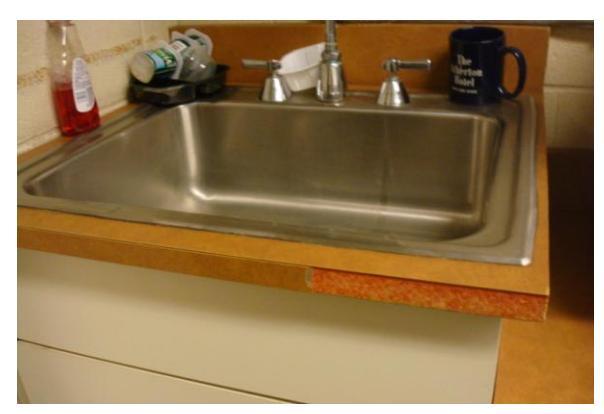
SINK WITH DELAMINATED EDGE

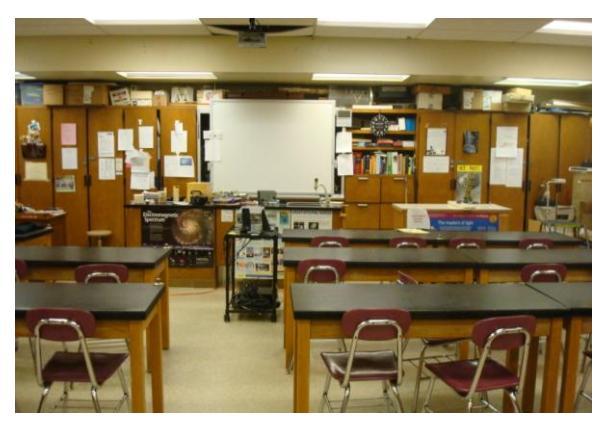
SCIENCE LAB WITH HUMIDITY SAGGED CEILING TILE (roof above has been repaired)

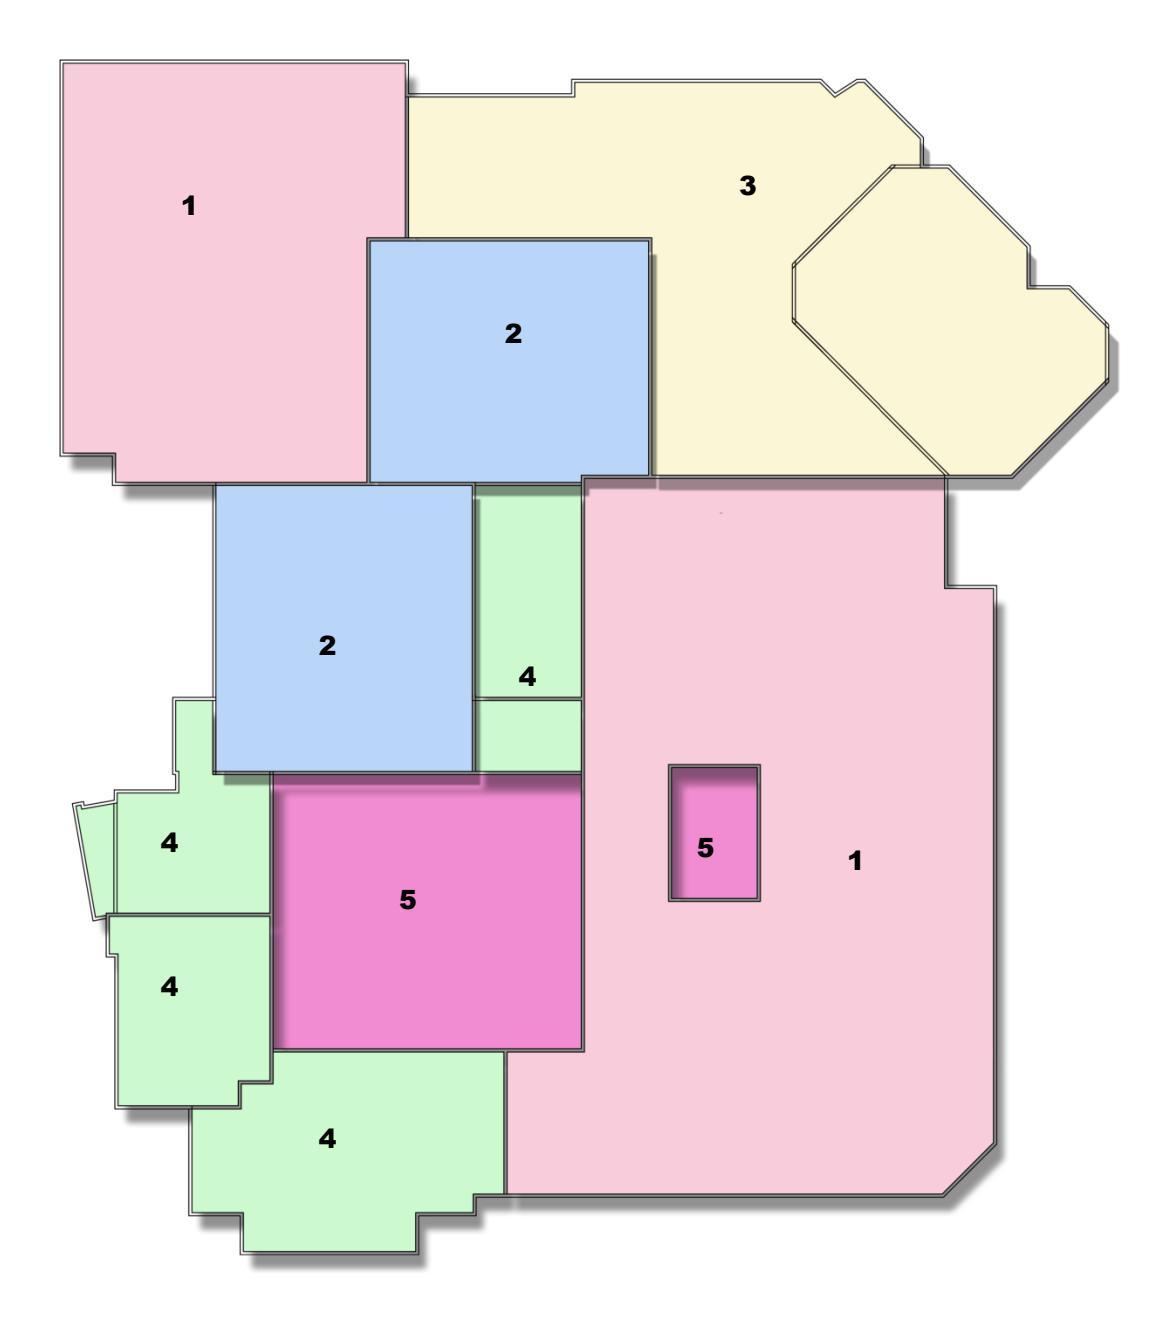
ROOF PLAN: Karns City Junior Senior High School

- 1 Existing Garland Roof, Warranty Expired 2013
- **2** Existing Garland Roof, Warranty Expired 2011
- 3 Existing Garland Roof, Warranty Expired 2012
- 4 Existing Siplast Surface Roof, Unknown Warranty
- 5 Existing Garland Roof Warranty Expires 2037
