KARNS CITY AREA School District

PHYSICAL NEEDS ASSESSMENT

FEBRUARY 2017

ASSESSMENT: Chicora Elementary School

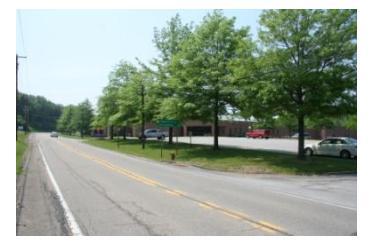
The Junior Senior High School site runs along the west side of Route 268. Although relatively flat with a gentle parallel to the road, the site beyond Route 268 is multi-level. A double tiered parking lot greets visitors as they enter the site. The upper lot is utilized by the Junior Senior High School and the lower lot for district Administration and Maintenance. As one continues around the building to the west, the earthen bowled track colored in red is available for viewing. The track has grandstands on two sides

It is recommended that the bleachers located at the football field be inspected for missing bolts and connectors. Portions of the bleachers give when stepped on. The pressbox is in need of electrical and finish updates.
